# Renewal and Reinforcement of Genta Bridge

FUJIP.S TECHNICAL REPORT

Bridge Name : Genta Bridge  
Location : Tottori  
Completion Year : 1951  
Structure : RC 16-span Continuous Gerber Girder Bridge  
Length : 357.9m  
Width : 6.5 m (Before widening 5.5m)

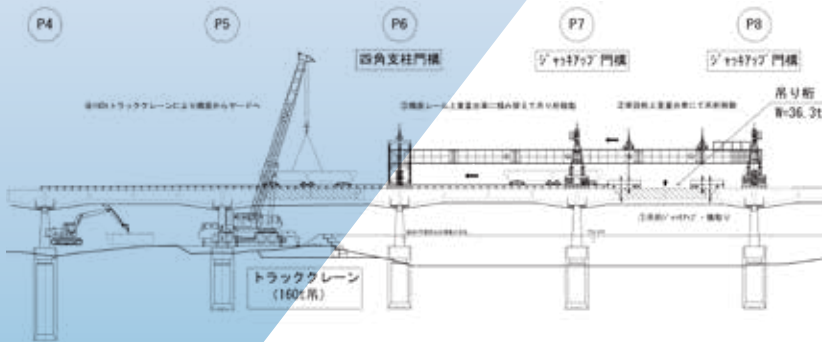
Suspended girder removal procedure diagram

For removal of suspended girders, pavement, slabs, horizontal girders, wheel guards were removed in advance and the suspended girders were removed independently. (Photo-2). The crane working radius was insufficient because the suspension girders of P7~P8 spans were located on the river. For this reason, the suspension girders were removed by using erection girder.

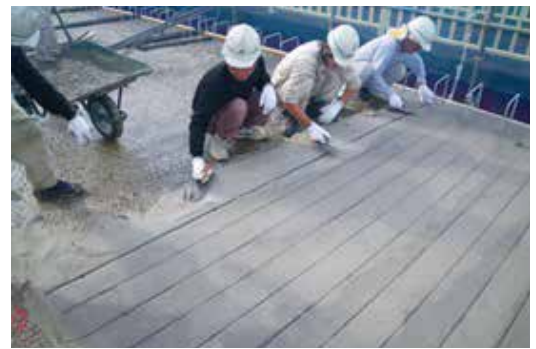
Photo-3 Erection of resin mortar and CFPR rod

The reinforcement of upper surface slab includes overlay method using concrete-based materials and adhesive method using the materials such as carbon fiber. When a construction method is selected, the primary requirement was to avoid an increase in the dead load due to reinforcement. Therefore, after comparative study of overlay method and adhesive method, the adhesive method was used (Photo-3).
